ODOR ASSESSMENT

**Department of Mental Health
Conference Room
1 Prince Street
Northampton, Massachusetts**

Prepared by:
Massachusetts Department of Public Health
Bureau of Environmental Health
Indoor Air Quality Program
October 2019

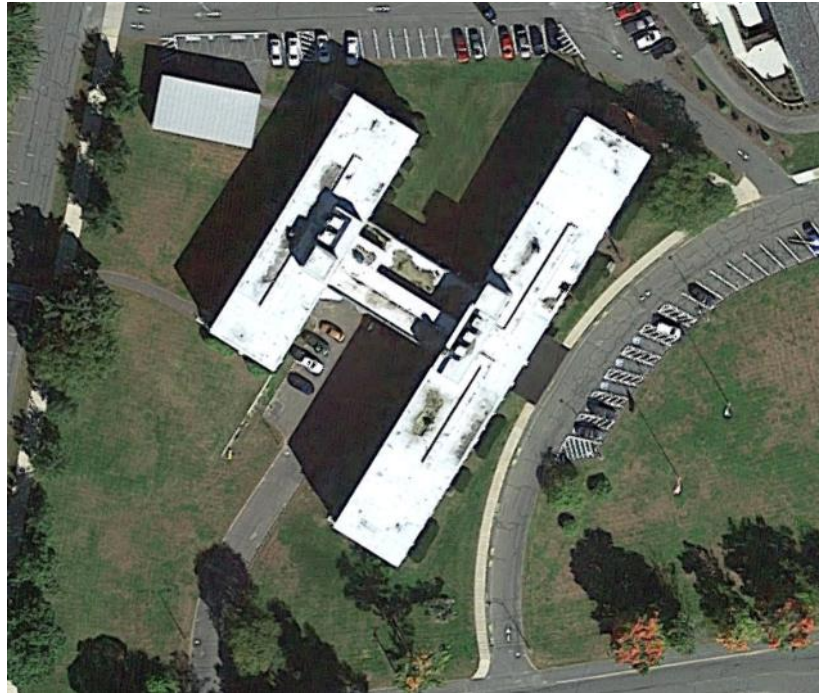
Picture 1

The conference room is connected to the building's heating, ventilation and air conditioning (HVAC) system, which has an air handling unit (AHU) located at the basement level. This HVAC system only provides heat. Fresh air is drawn through a vent located on a west-facing exterior wall near the loading dock (Picture 1). The AHU is connected to the conference room to supply (Picture 2) and return/exhaust (Picture 3) vents.

- The restroom did not have an operating exhaust vent. Water vapor from the drains and toilet could then migrate into the conference room via a passive door vent (Picture 7).
- The restroom had a window open (Picture 8), which can allow for hot, moist air to enter the conference room via the passive door vent. It may also pressurize the restroom and push air into the occupied areas outside the restroom through the door vent.
- There are sinks in the restroom and anteroom which may have dry drain traps. Water vapors and odors from the sewer/septic system can migrate into occupied areas if drain traps are dry.
- There was also rolled up carpet over the sink which can become moistened from water vapor exposure (Picture 9).
- Hot, moist air may migrate to the conference room under westerly/southwesterly wind conditions via the deactivated HVAC system (Picture 1).

Aerial view of building, fresh air intake is in the courtyard

1. Consider temporarily sealing the fresh air intake of the HVAC system during hot, humid weather with a non-porous, solid material to prevent wind-driven hot, moist air from entering the building.

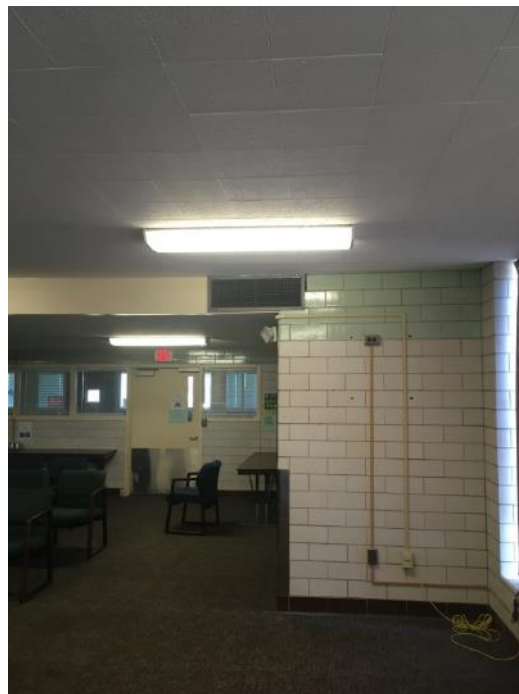
Picture 2

Conference room fresh air supply vent

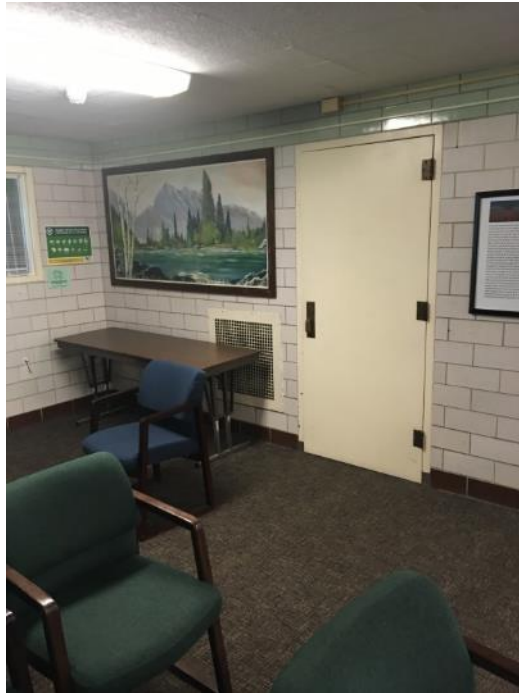
Picture 3

Conference room exhaust/return vent on wall

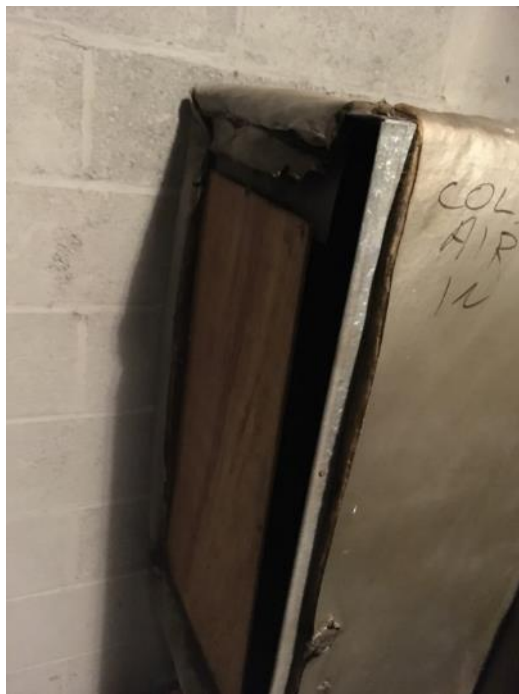
Picture 4

This HVAC system was deactivated at the time of this assessment. The HVAC system in the basement was examined and found in poorly modified condition with plywood in place of ductwork (Picture 4). Significant airflow was noted with the HVAC system deactivated which likely indicates that outdoor air dampers are open. In this condition, hot, moist air can enter

through the HVAC duct as a means to introduce unconditioned, humid air into the conference room and other areas connected to this HVAC system.

Plywood used in HVAC system ductwork

1. Consideration should be given to replace HVAC units/components as they become past their service life. If not conducted already, consider contacting an HVAC engineering firm for an assessment of the ventilation system’s components and control systems (e.g., controls, air intake louvers, thermostats). Based on the age, physical deterioration, and availability of parts for ventilation components, such an evaluation is necessary to determine the operability and feasibility of repairing/replacing the equipment.

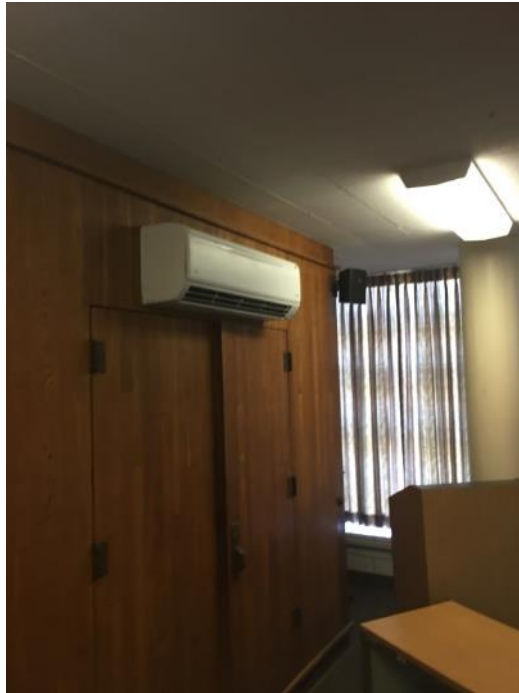
Picture 5

The conference room has two wall-mounted air conditioners (Picture 5) which were in operation during this visit. These units do not supply any fresh air, only cool existing room air.

Wall-mounted air conditioner in the conference room

8. Ensure that condensation from air conditioning equipment is draining properly. Check collector pans, piping and any associated pumps for clogs and leaks and clean periodically to prevent stagnant water build-up and remove debris that may provide a medium for microbial growth.

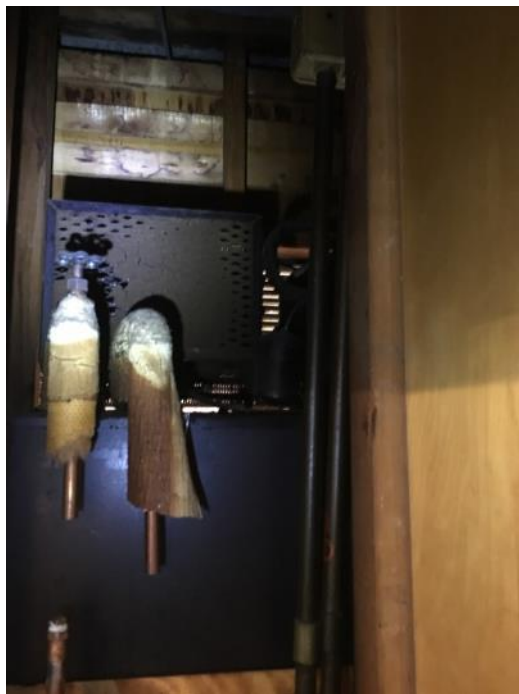
Picture 6

Of note is a large wooden closet/cabinet that appears to be water-damaged from a water fountain that had previously been in the space. Inside the wood closet appears to be a disused water chilling system for the fountain. Mold-colonized insulation was noted (Picture 6). An air intake and deactivated water coils were found caked with debris. Water-damaged wood and coil

debris can become musty if exposed to significant humidity. Several conditions may exist in the conference room and an adjacent restroom area that would be significant sources of water vapor.

Caked debris on vent inside closet and water-damaged insulation

2. Remove water-damaged wood from the cabinet.
3. Clean and or remove debris-caked materials associated with the removed water fountain system.
4. Ensure that all drains are wet at least twice a week to maintain the trap seal.

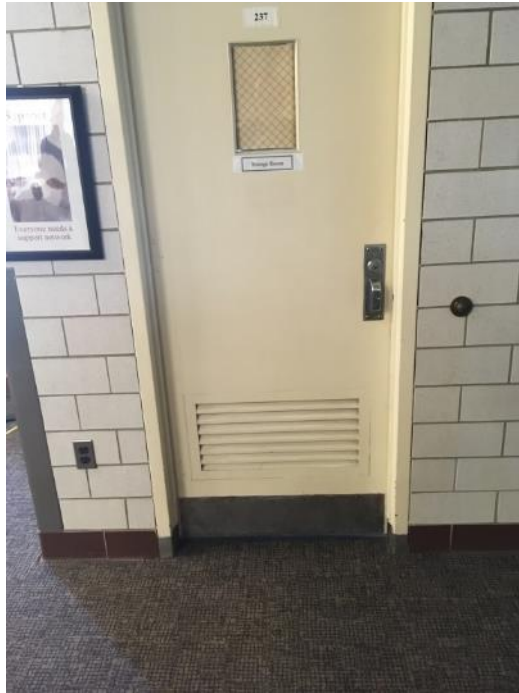
Picture 7

Passive door vent to restroom in conference room

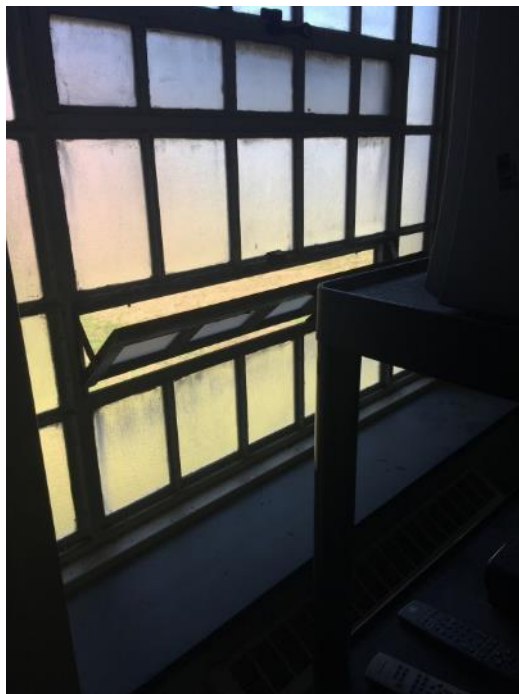
Picture 8

Open window in restroom

5. Do not use windows while AC system is operating in its chilling mode to prevent condensation/mold growth.
6. Remove porous materials from bathroom anteroom.

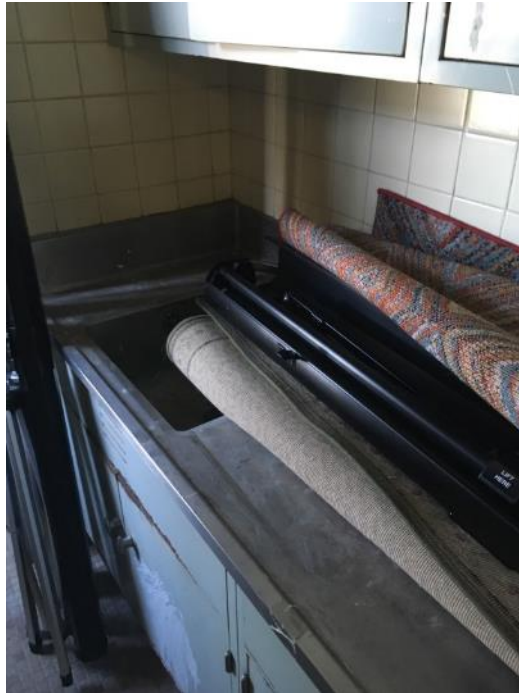
Picture 9

Carpet over sink in restroom anteroom
